DEPARTMENT OF TRANSPORTATION

Contract #: 04-0120F4Cty: SF/ALA Rte: 80 PM: 13.2/13.9File #: 99.28**WELDING INSPECTION REPORT****Resident Engineer:**Siegenthaler, Peter**Address:** 333 Burma Road**City:** Oakland, CA 94607**Report No:** WIR-019917**Date Inspected:** 13-Jan-2011**Project Name:** SAS Superstructure**OSM Arrival Time:** 700**Prime Contractor:** American Bridge/Fluor Enterprises, a JV**OSM Departure Time:** 1900**Contractor:** Zhenhua Port Machinery Corporation, Ltd (ZPMC), Changxing Island **Location:** Shanghai, China**CWI Name:** Mr. Xu Tao**CWI Present:** Yes No**Inspected CWI report:** Yes No N/A**Rod Oven in Use:** Yes No N/A**Electrode to specification:** Yes No N/A**Weld Procedures Followed:** Yes No N/A**Qualified Welders:** Yes No N/A**Verified Joint Fit-up:** Yes No N/A**Approved Drawings:** Yes No N/A**Approved WPS:** Yes No N/A**Delayed / Cancelled:** Yes No N/A**Bridge No:** 34-0006**Component:** Steel Barriers**Summary of Items Observed:**

WELDING INSPECTION REPORT

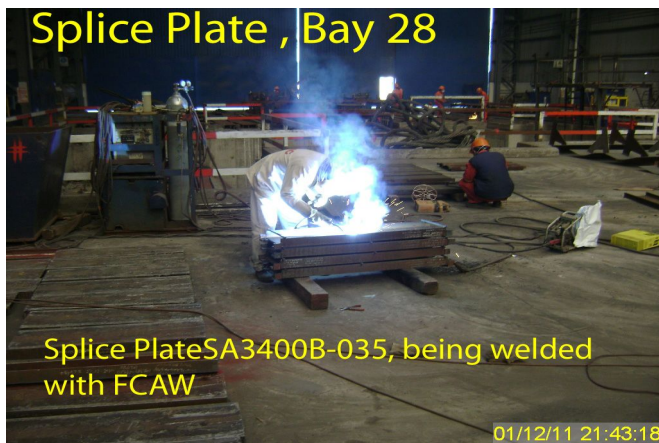
This QA inspector performed MT testing on 10% of an area that has been previously tested and accepted by ZPMC Quality Control (QC) personnel. This QA Inspector Delbert Humphrey generated an MT report for this date. Time of inspection was 9:00 hours. The members are identified as follows OBG, Steel Barrier, The weld designations reviewed are as follow: SA3321B-001~036-003-004

Unless otherwise noted, all work observed on this date appeared to be in general compliance with the applicable contract documents.
